Omron helps healthcare company minimize defects with can flange inspection system

Case study | October 2019

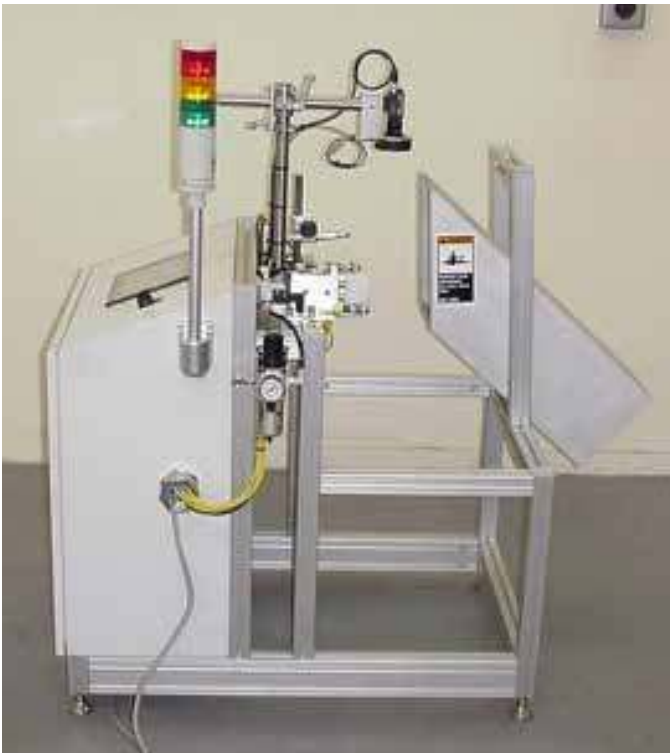
A complete Can Flange Inspection System was built by an Omron machine builder partner.

As part of the Can Flange Inspection System, Omron provided a complete control panel and camera/light mounting assembly to fit around the existing conveyor. The control panel, HMI, cameras and light were all mounted on this assembly. The electrical control panel containing all of the electrical control components, including the main controller, vision controller, light strobe controller and power supply, was fabricated in a painted steel enclosure. An 8-inch color touch screen HMI device with a video input option for displaying the vision system camera image was mounted in a separate enclosure and located near the inspection camera.

To address concerns about cans falling from the high platform, the design team integrated a reject bin guide tunnel into the inspection system. When a defective can is rejected, it is blown off the conveyor into a tunnel that guides it into a reject bin. The tunnel was made large enough to ensure that no cans would miss the target and fall onto the plant floor. To resolve the issue of can speed and separation, Omron designed a dual-wheel mechanism to separate cans ahead of the inspection site that allows them to maintain their high speeds. These two systems were integrated into the inspection system assembly described above.

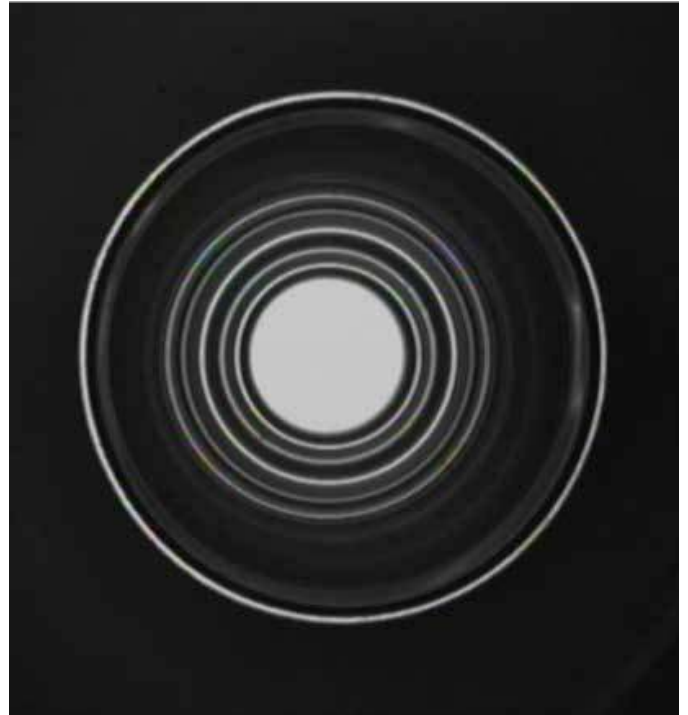
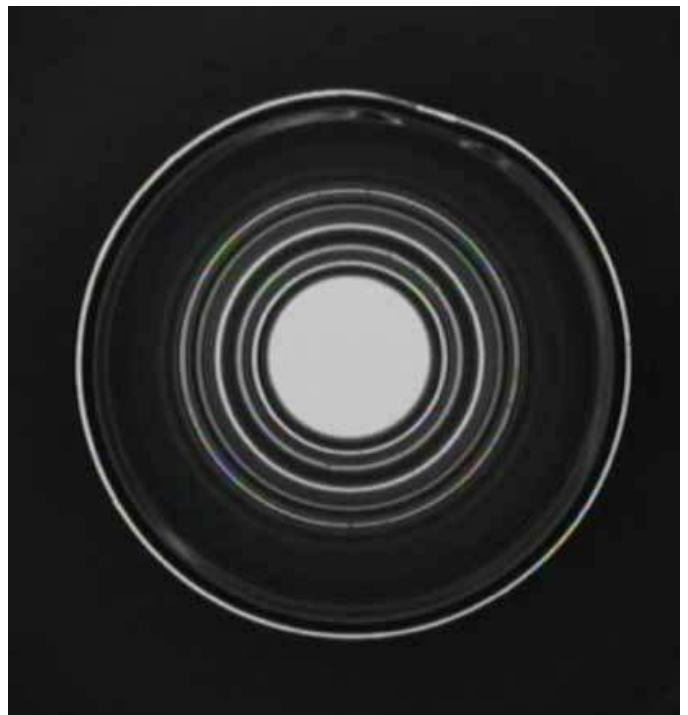
These two images of cans as seen by the camera illustrates how the lighting helps make each can's edges bright to facilitate inspection for circularity and defects. The image on the left shows a properly-formed can, while the can on the right has a defect.

The inspection camera was set up directly above the can, approximately 8 inches from its top and facing down onto the its flange area. A red low-angle ring light was set up just below the camera lens to highlight the flange, creating an excellent reflected ring on the flange of the can. The ring light causes

the light to reflect off the outer edge of the can, turning the flange area into a solid white ring and making it easy to see its circular shape. If the can flange is defective, the rim of the can will have dents showing up as distortion of the circular shape.

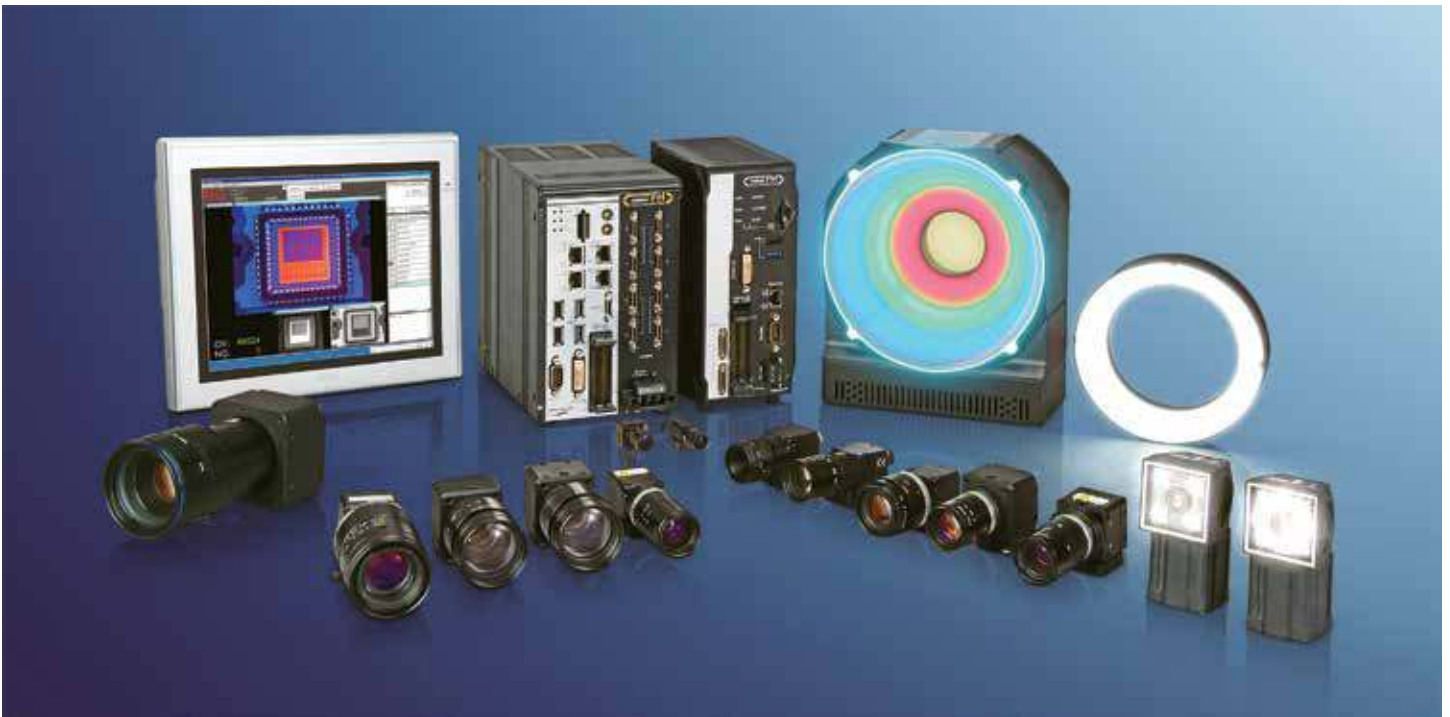
FH series vision system – High-speed, high-accuracy inspection and measurement

Omron's powerful FH Series vision system provides high-speed, high-accuracy inspection and measurement for a wide variety of industry needs. Because the amount of image information in manufacturing is increasing, Omron developed this vision system to meet rapidly growing automation needs and higher performance requirements. Packed with technologies, the FH Series enables more customers to easily employ image processing.

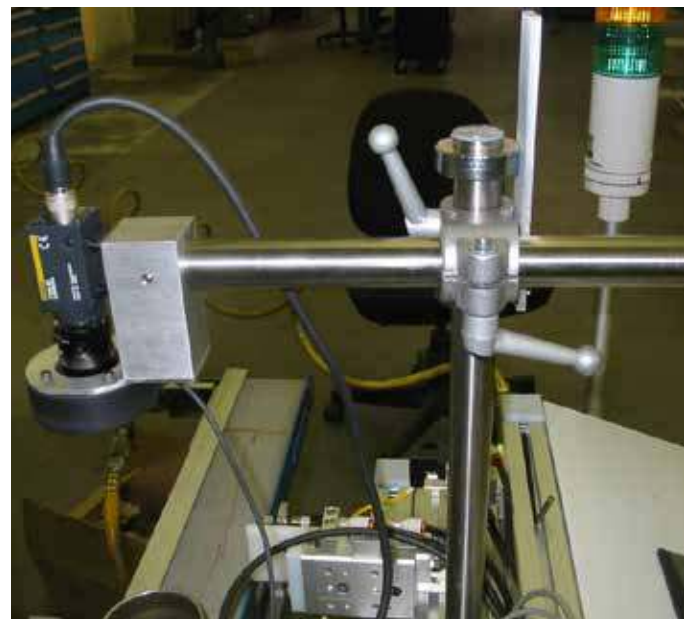
The camera and the low-angle ring light are mounted above the conveyor, with the camera's position capable of being manually adjusted in two directions.

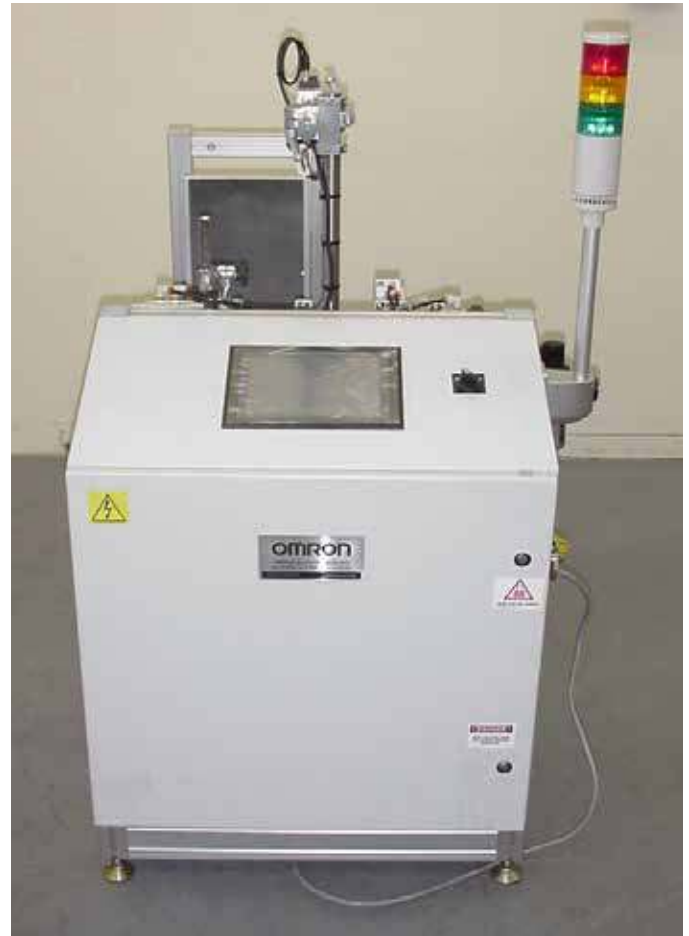
The Can Flange Inspection System's front view shows the control panel and the operator panel.
