Correction Of Varnish Problems In A Power Plant Turbine

Technical Application Bulletin

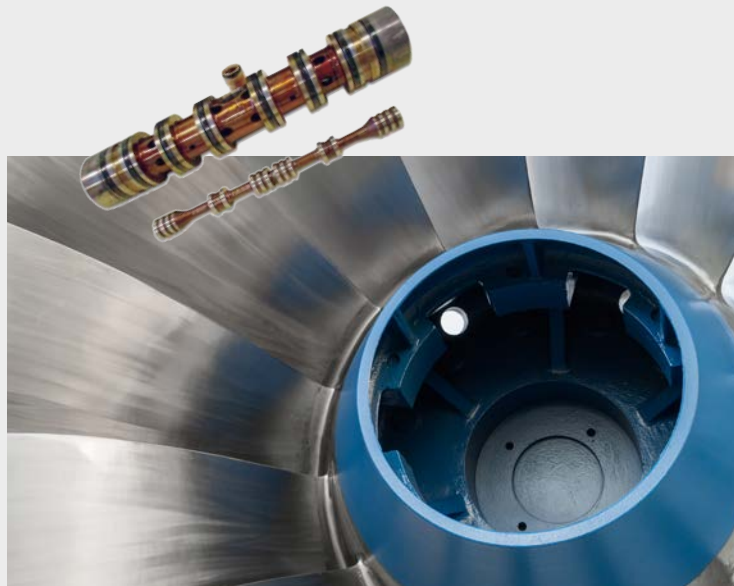
In this case, a stationary system was selected that constantly removes oil aging products from the turbine oil.

What We Did: On the basis of the analysis, the customer began using a Schroeder VMU | Varnish Mitigation Unit a service-friendly filter power unit to remove oil aging products (varnish) from mineral-oil-based turbine oil:

The VMU is used in the bypass flow and offers the following product features:

- Removal of solid or gel-like oil aging products
- Flow rates between 2.2 and 8.9 L/min
- Available as mobile or stationary system
